From Design to Disaster: Analysis of the Florida International University Pedestrian Bridge Collapse

Robert Sumwalt
January 30, 2020

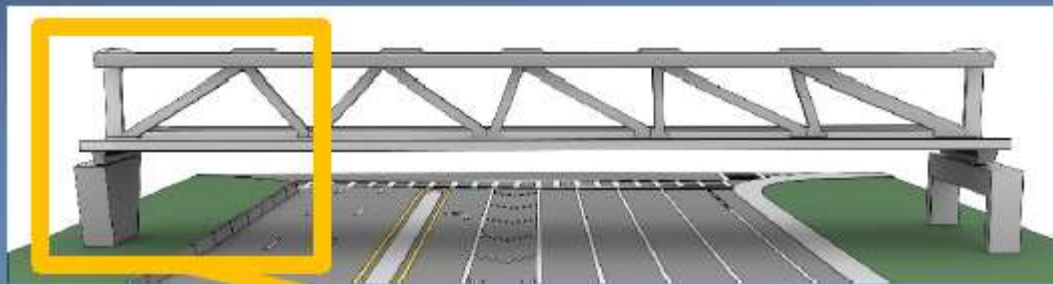
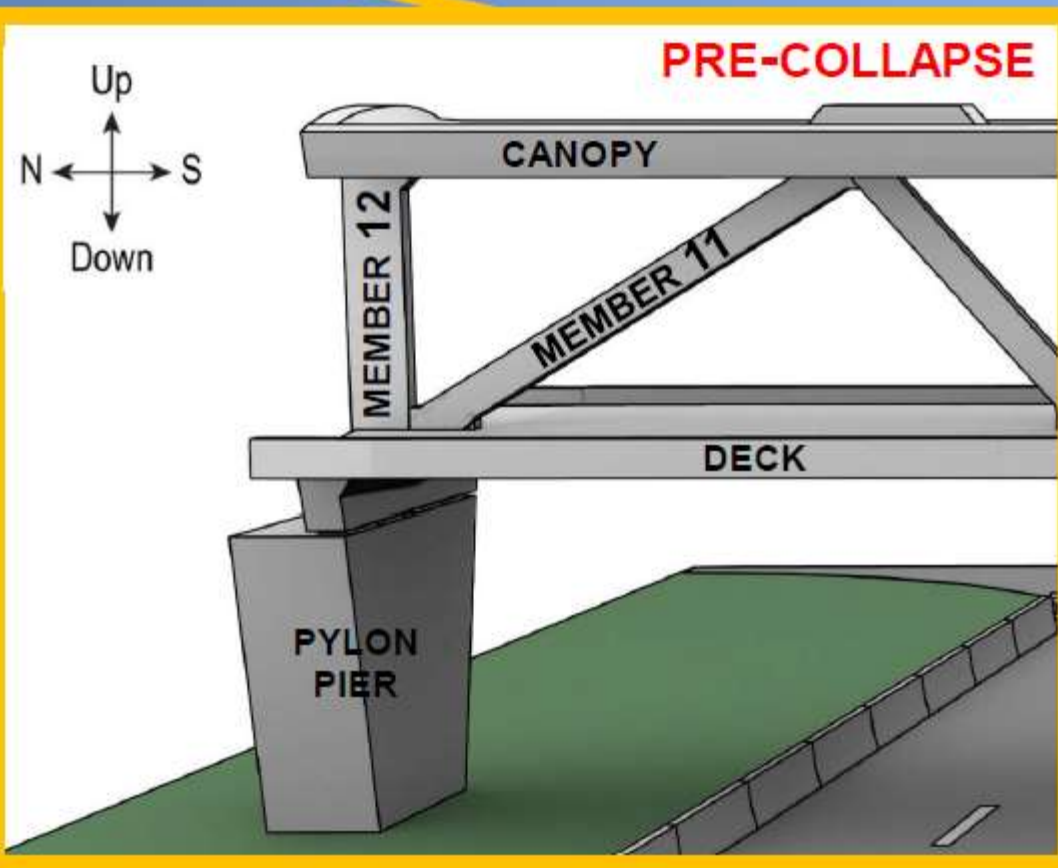
Concrete
blowout

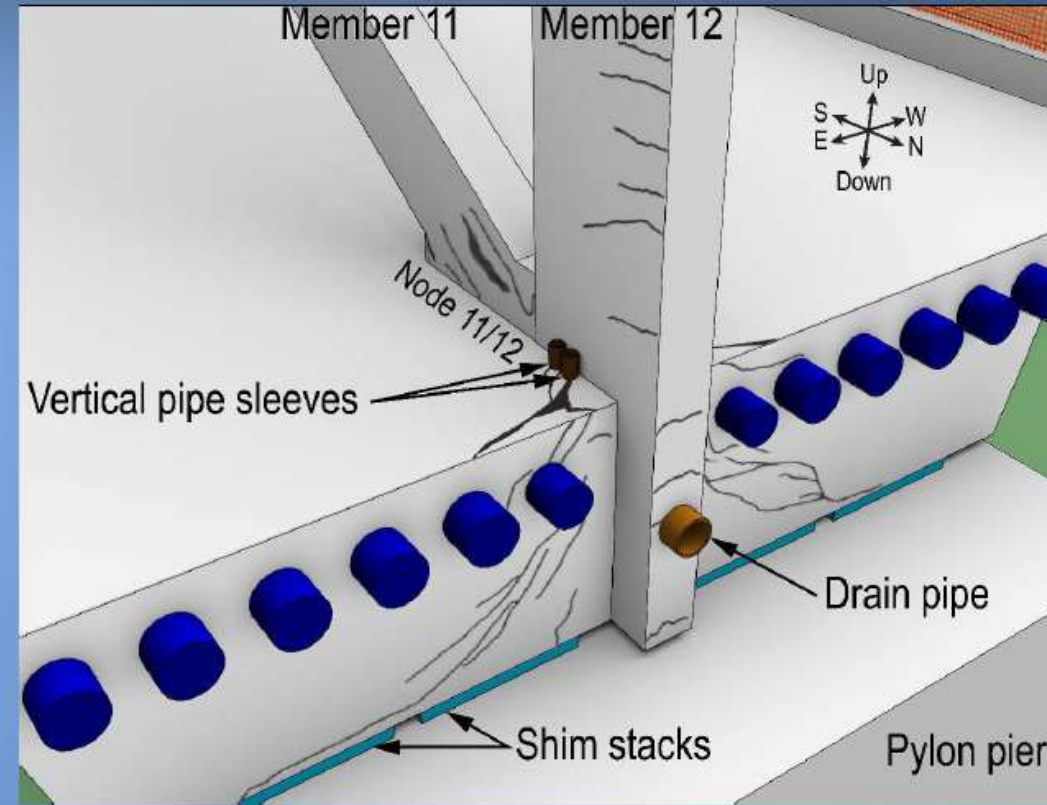
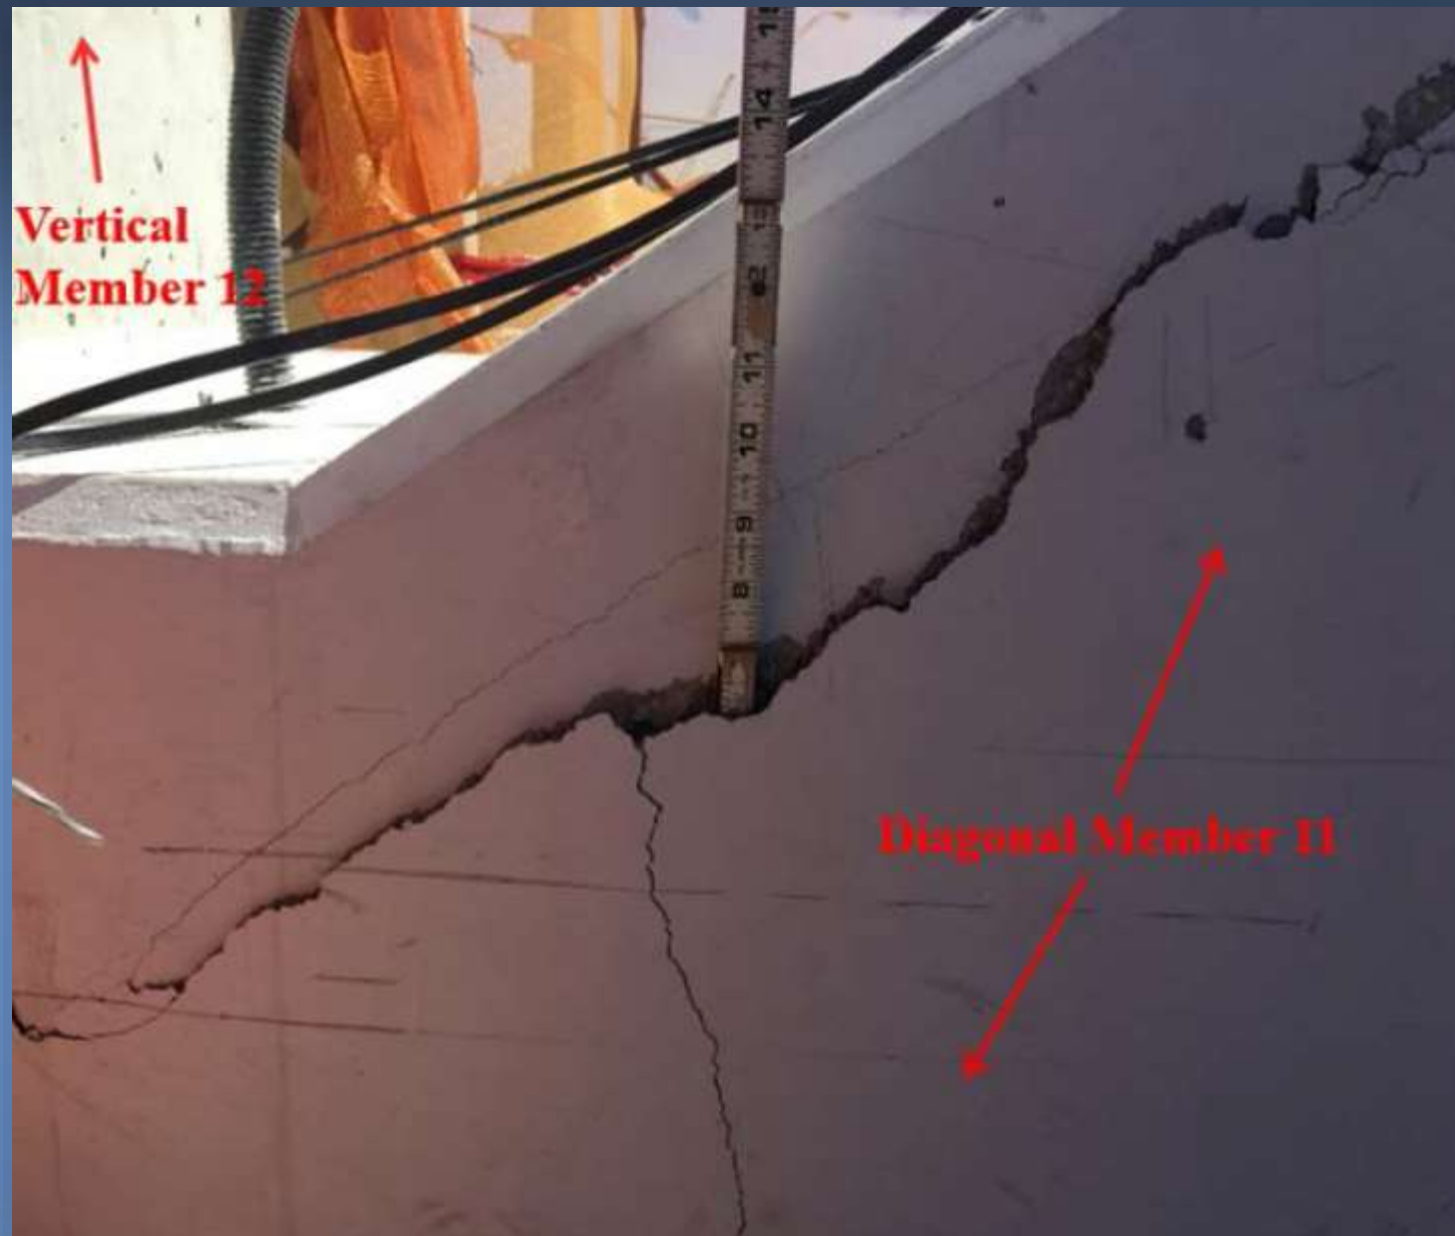
Cracking in Member 11/12 Nodal Region

- Structure showed notable cracking of reinforced concrete
- Extensive and large cracks in member 11/12 should have been recognized as abnormal
 - Cracks up to 0.016 inch wide – considered acceptable
 - Structural cracks in bridge were up to 0.75 inch wide – 40 times larger than typically acceptable
- Scale of cracking clear indication that load-resisting mechanisms were failing

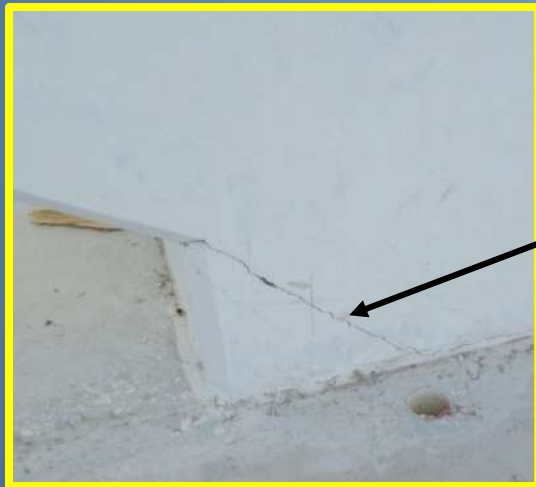
- Portion of crack bypassed 25% of reinforcing steel at base of member 11

Crack passed above the southernmost two size 7 rebars

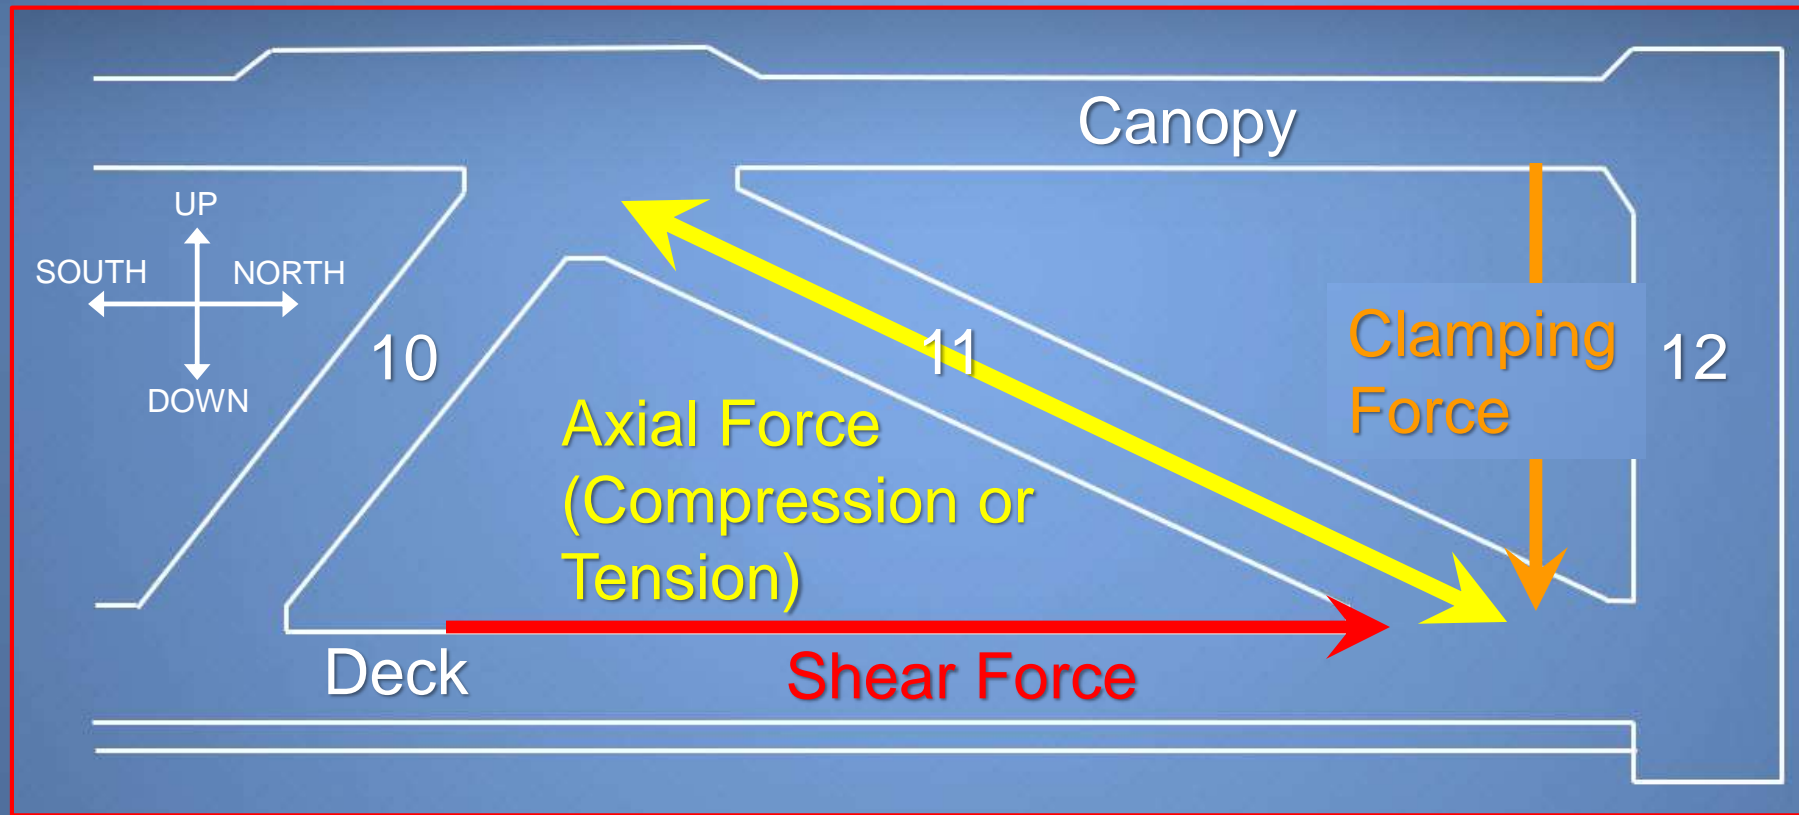
Forces on 11/12 nodal region

Magnitude of
horizontal force –
60 percent larger
than vertical force

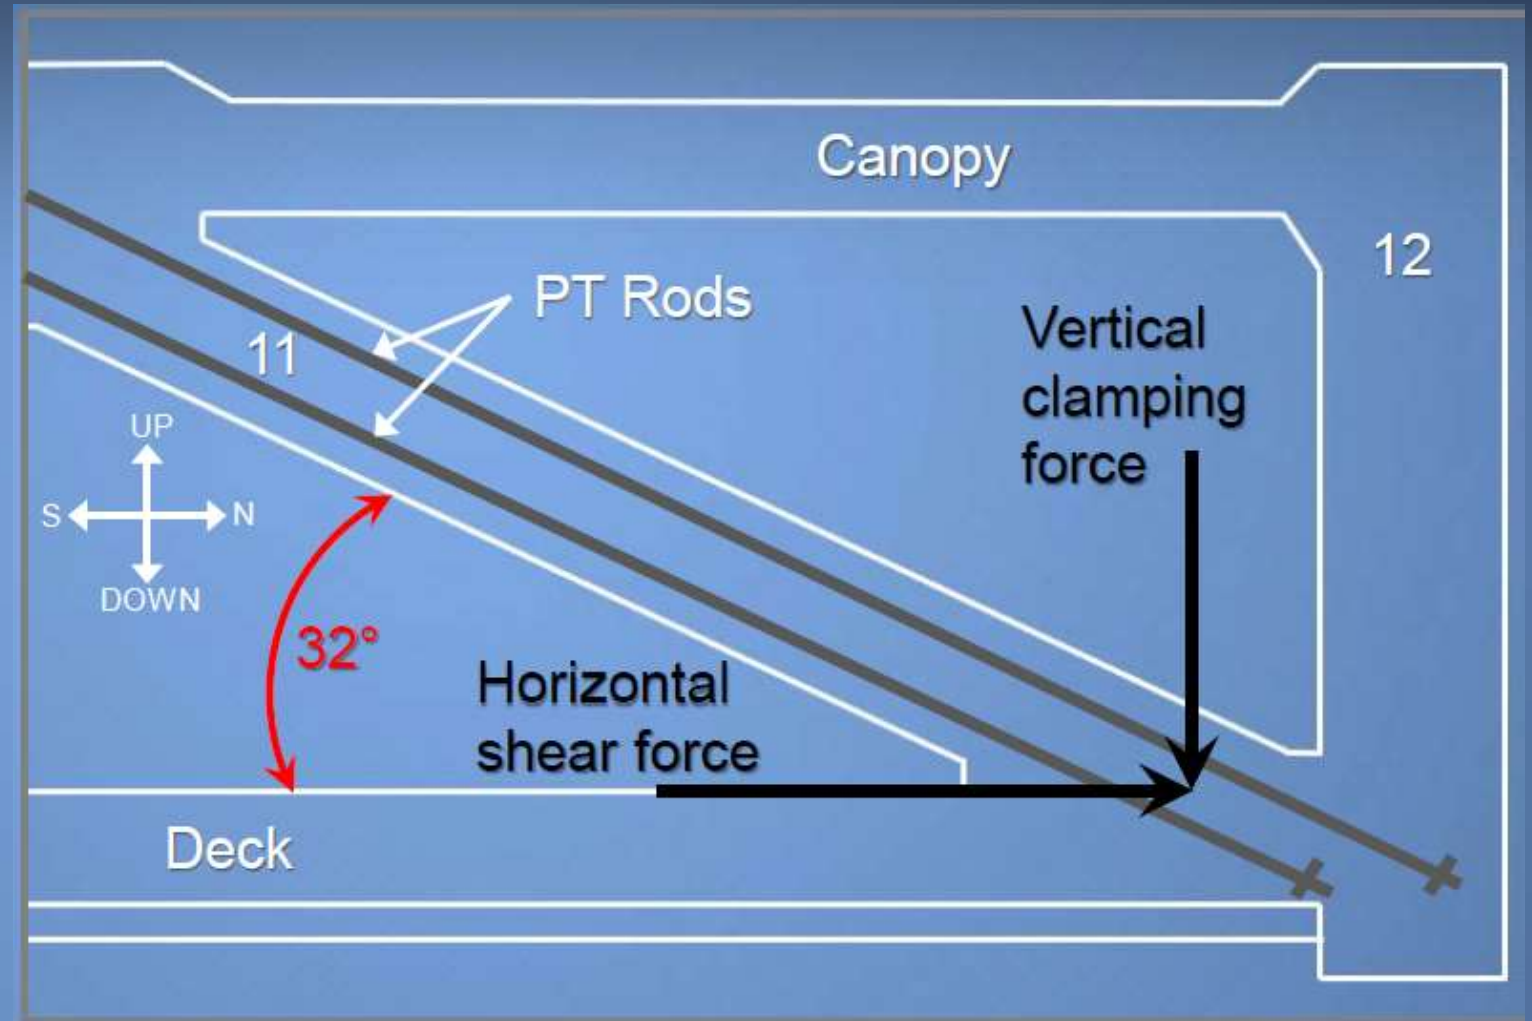
Interface Shear Demand

Figg underestimated interface shear demand at nodal region 11/12 by 46%.

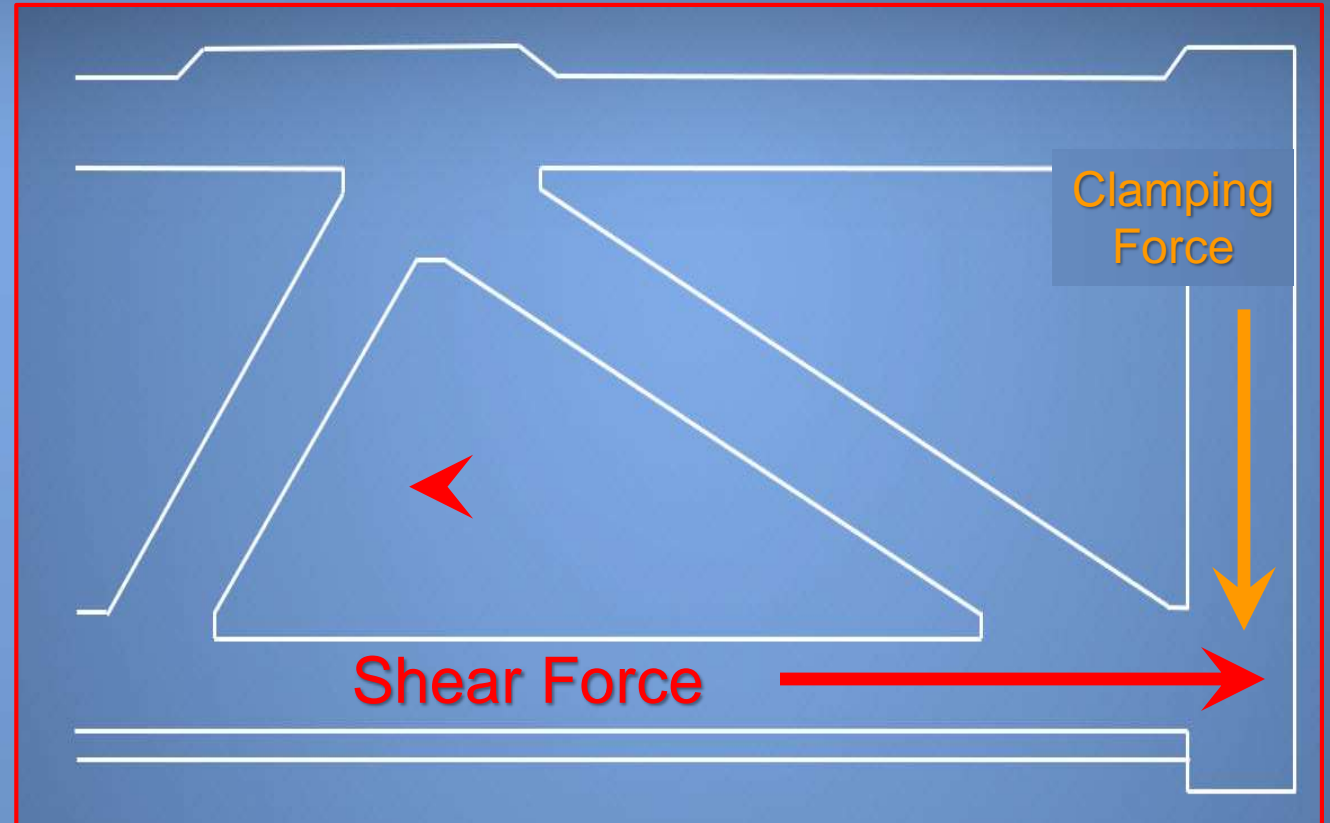
270 percent more rebar needed

- Member 11 needed 18 square inches cross sectional area of rebar.
- It only had 4.8 square inches.

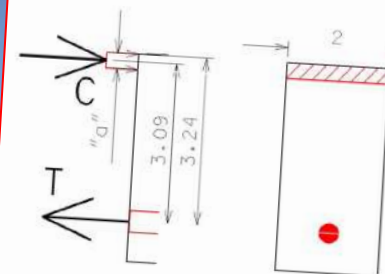
Bending Check – Beam Theory

- Steel Area = 13.1 in^2
- $T = (13.1)(60 \text{ ksi}) = 786 \text{ kips}$
- $f'_c = 8.5 \text{ ksi} = 1224 \text{ ksf}$
- $(a)(.85 f'_c)(b) = C = 786 \text{ kips}$
- Solving, "a" = 0.38 ft
- $M_n = (T)(d - (a/2)) = 786 \times 3.09' = 2398 \text{ kip-ft (nominal capacity)}$
- $\Phi = 0.9$, so $(\Phi)(M_n) = 2158 \text{ kip-ft}$
- Which is larger than $M_u = 2015 \text{ kip-ft}$
- Check OK
